**Keeyask Generation Project**  
**Causeway to Borrow N-5 – Description of Repair**

Manitoba Hydro, in its delegated authority to manage construction of the Keeyask Generation Project on behalf of the Keeyask Hydropower Limited Partnership, is submitting the proposed repairs to the causeway to Borrow N-5. These modifications are in response to the high ice and water levels experienced in the winter of 2014/15 and the risk that a stable ice cover does not develop upstream of Gull Rapids in future years when construction is occurring. Manitoba Hydro is requesting that culverts not be re-installed in the causeway to Borrow N-5 (Map 1) and is including information regarding the repairs to the abutments.

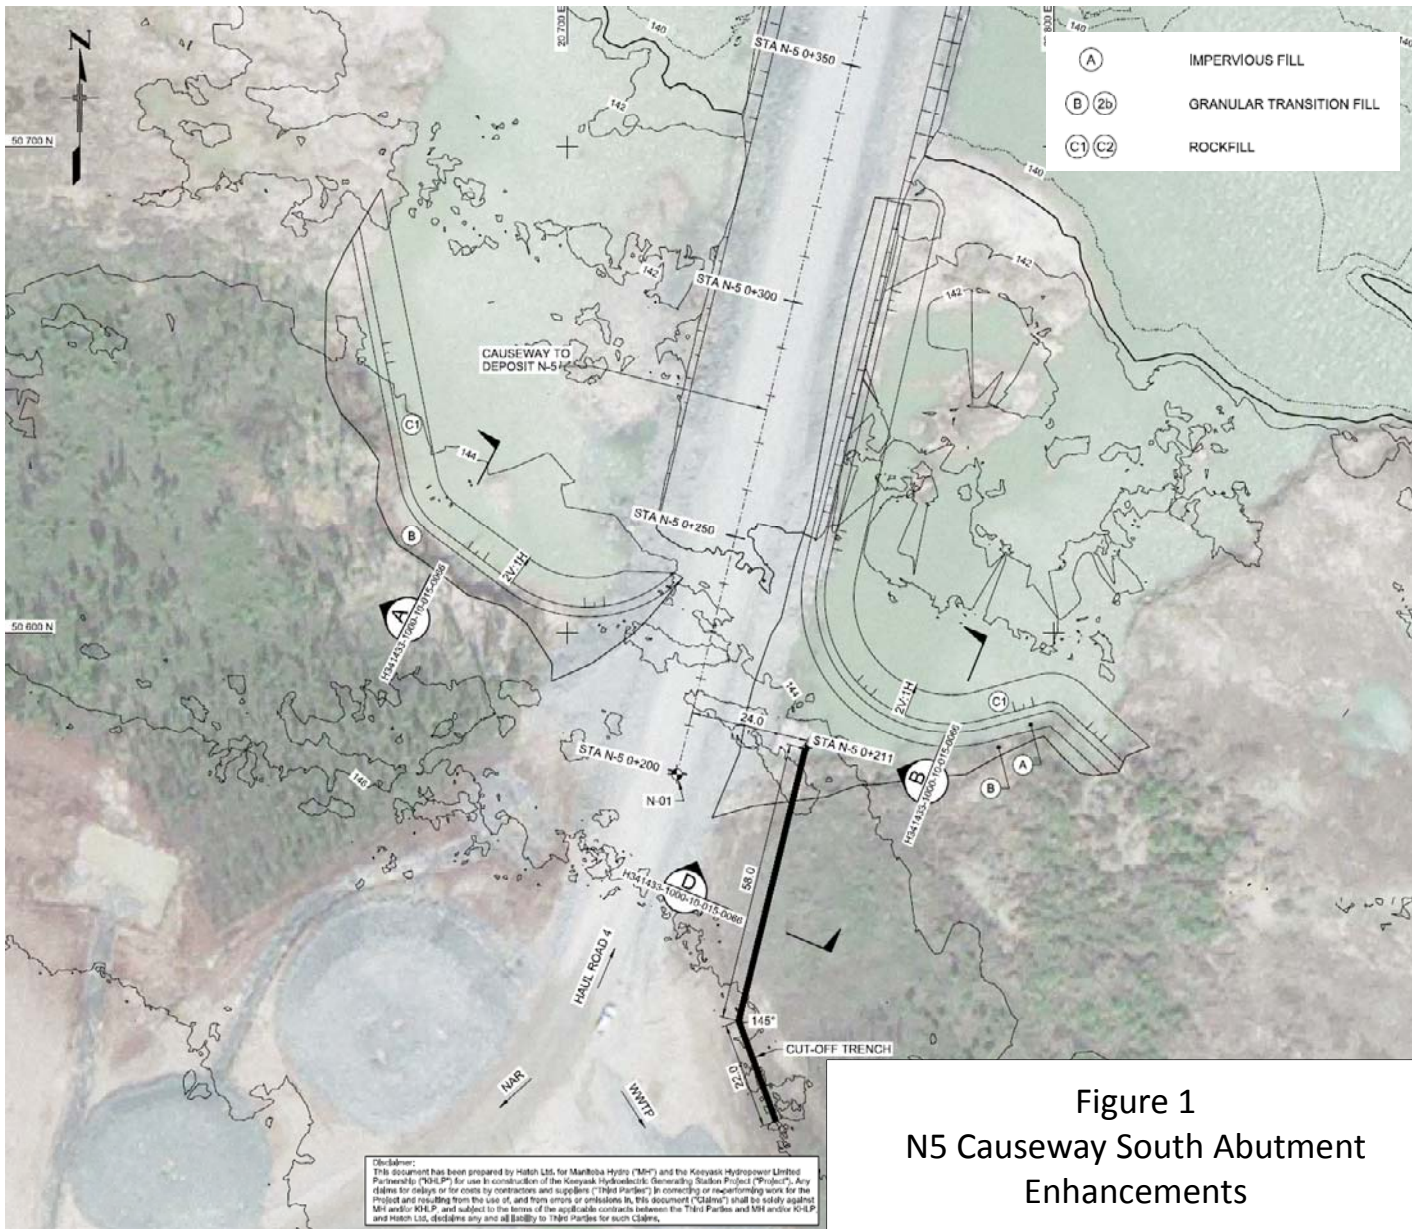
Figure 1  
N5 Causeway South Abutment  
Enhancements

As stated earlier, the construction design flood water levels were based on a stable ice cover forming upstream of Gull Rapids. As a result of no stable ice cover formation upstream of Gull Rapids until late in January 2015, water levels at the causeway were higher than anticipated resulting in erosion at the culvert locations and the south abutment. The erosion caused sink holes to form in the causeway which impacted the safety of workers driving the causeway. The culverts were placed on and backfilled with finer bedding material which was not able to withstand the high seepage velocities around the culvert caused by the high water level. The abutment was constructed on fine grained sandy silt. High water levels created high seepage velocities that eroded the overburden material. The causeway was also overtopped near the south abutment which shut down access to the causeway for a period of time.

In order to prevent additional erosion of the south abutment and shore line the measures listed below will be implemented. These measures are shown in Figure 1.

- Granular and impervious material will be placed on the east side to reduce seepage through the abutment.
- A cut-off trenched filled with impervious material will be placed on the east side and will reduce

seepage through the abutment.

- Granular material will be placed on the west side of the abutment to prevent abutment soils from washing away.
- Rock fill will be placed along the shoreline to protect the newly placed granular and impervious material.

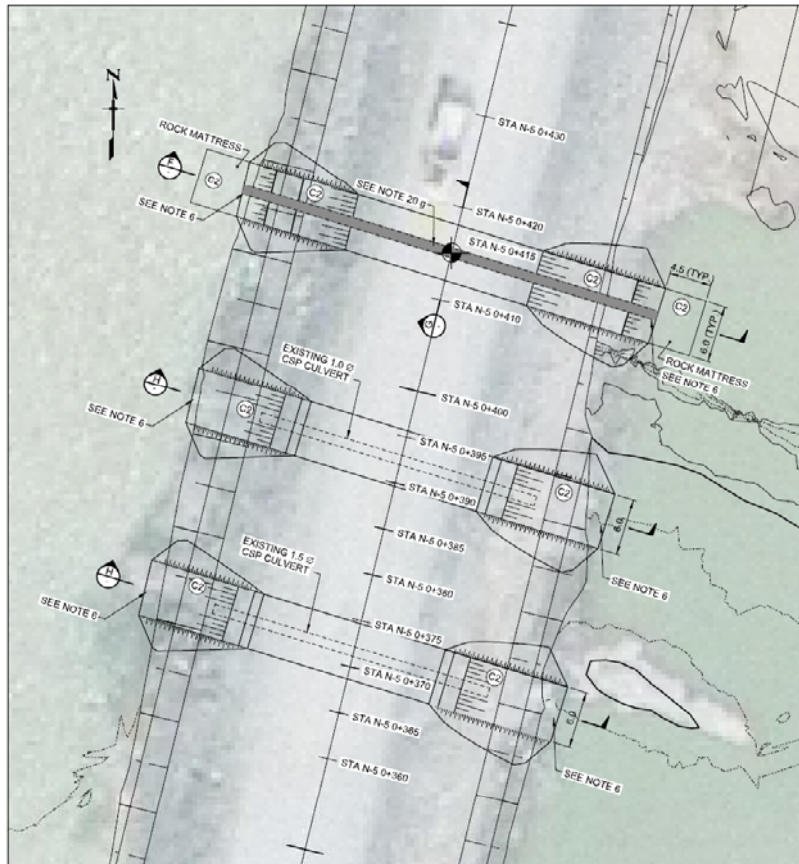
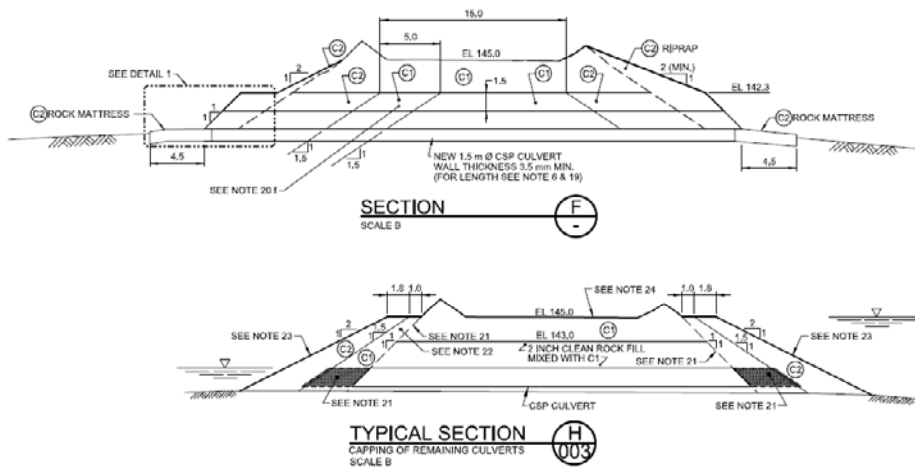
Figure 4  
N5 Causeway Culvert Removal  
& Capping Details

Even though additional measures have been put in place to promote the formation of a stable ice cover early in the winter season, there is still the risk that it will not form. If this occurs, there is a high potential that any new culverts placed into the causeway to Borrow N-5 would again experience erosion causing sink holes to form in the causeway. As well, additional work must be done to repair the damage occurred in the winter of 2014/15.

Capping the existing culverts would entail flattening each end of the culvert and covering with layers of Class 1, Select Class C1 and Class C2 rock fill as shown in Figure 4. The different layers of rock in the caps will be graded to prevent further erosion of material around the culvert and avoid development of sink holes. Much of the fine material washed out during the winter of 2014/15 which further reduces the potential for erosion at the culverts.

20. CONSTRUCTION WORK FOR THE N-5 CAUSEWAY CULVERT REPLACEMENT SHALL IN GENERAL INCLUDE THE FOLLOWING KEY STEPS:
  - a. ALL EXCAVATION WORK SHALL AT MIN. COMPLY WITH THE WORKPLACE SAFETY AND HEALTH ACT INCLUDING THE GUIDELINES FOR EXCAVATION.

- b. REMOVE TRENCH BACKFILL TO THE ORIGINAL TRENCH WIDTH EXPOSING THE C1 ROCKFILL TRENCH FACES. ALL 2 INCH CLEAN ROCKFILL TO BE REMOVED.
  - c. REMOVE EXISTING 1.0m Ø CSP CULVERT.

- d. CONSTRUCT THE ROCK MATTRESSES AT THE TOE OF EACH SLOPE BY PLACING C2 ROCKFILL TO EL 139.3.
  - e. CULVERT BEDDING MATERIAL TO CONSIST OF C1 ROCKFILL TO EL 139.3.

- f. BACKFILL 15.0 m CENTER OF THE TRENCH WITH C1 ROCKFILL, THE DOWNSTREAM 5.0 m PORTION TO BE BACKFILLED WITH SELECT WITH SELECT C1 ROCKFILL (i.e., >75 mm). BACKFILL THE REMAINING ENDS OF THE TRENCH BY PLACING C2 ROCKFILL TO EL 142.3.

- g. THE METHOD USED TO BACKFILL THE TRENCH SHALL NOT DAMAGE THE CULVERT AND BE APPROVED BY THE ENGINEER PRIOR TO WORK COMMENCING.
  - h. BACKFILL THE TRENCH AND RESTORE THE CAUSEWAY TO EL 145 WITH C1 ROCKFILL.

- i. PLACE C2 ROCKFILL TO FROM THE OUTER SHELL OF THE CAUSEWAY.
21. REMOVE EXISTING CULVERT (AS NEEDED) AND SLOPE TO 1:1.
22. BACKFILL WITH SELECT C1 ROCK FILL (D>75 mm).

23. BACKFILL WITH C2 RIPRAP.
24. APPLY HIGH AMPLITUDE VIBRATORY COMPACTION AS THE TRENCH LINE IN AN EFFORT TO COLLAPSE ANY NEAR SURFACE VOIDS, BACKFILL VOIDS TO RESTORE CREST ELEVATION AS NECESSARY.
