INTRODUCTION

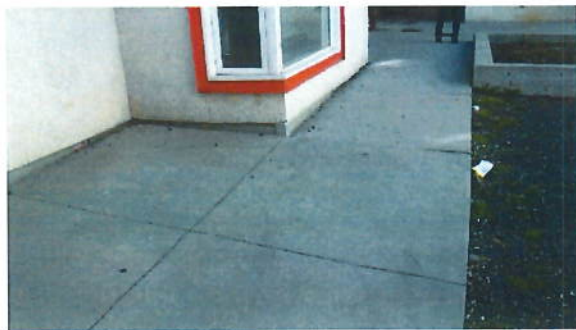
Fig. 1.: Jacking corner of Bldg A (unit a8).

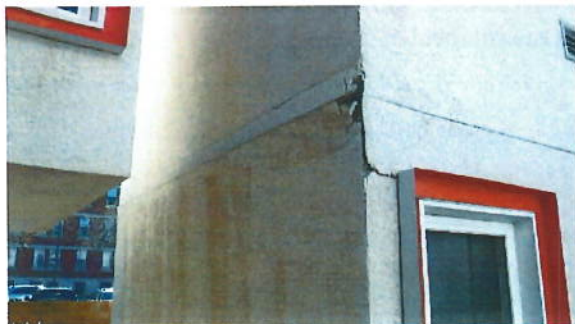
Fig. 3: Damaged wall and stucco due to jacking.

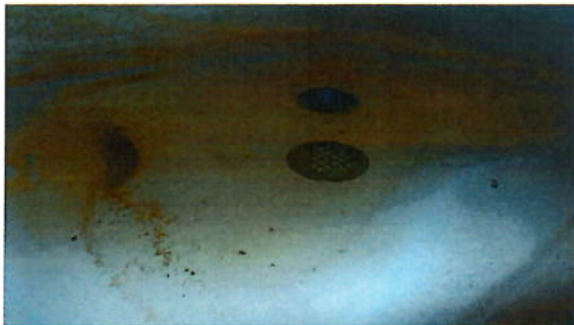
Fig. 4: Shower drain lifted out of shower floor.

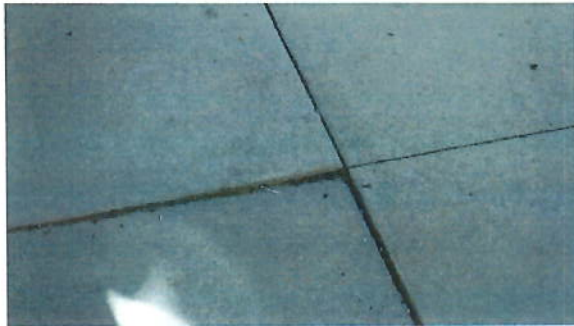
Fig. 7: Example of uneven sidewalk.

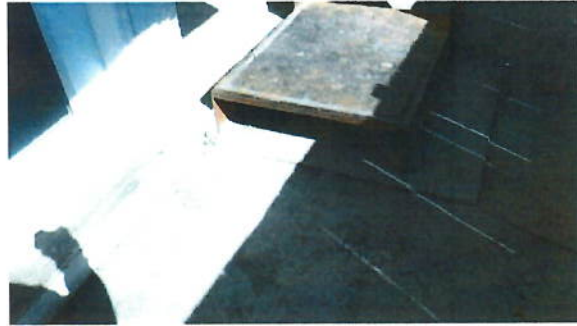
Fig. 8: Multiple elevations to walk through: concrete pad to left of metal platform, metal platform, lower concrete slab, uneven/unmatched sidewalk.

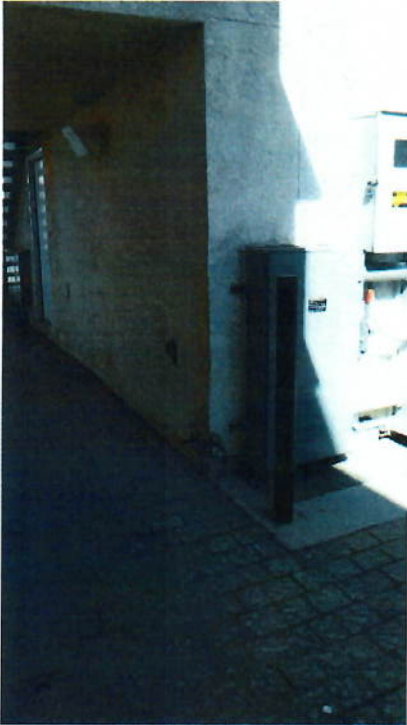
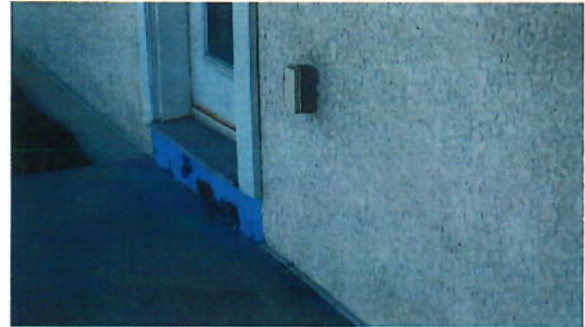
Fig. 9: Example of missing stucco below door.

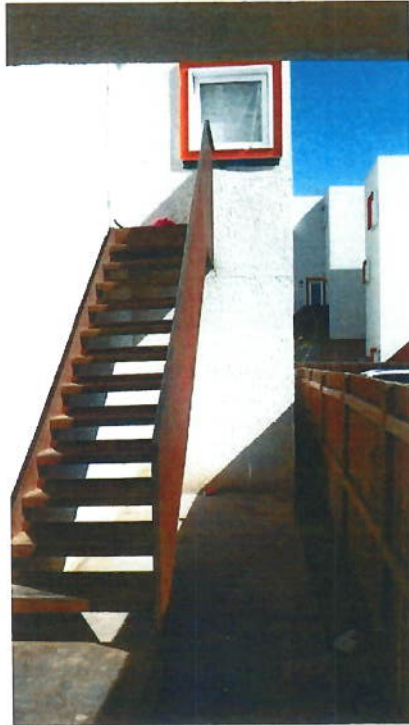
Fig. 11: Example of corroding stairs.

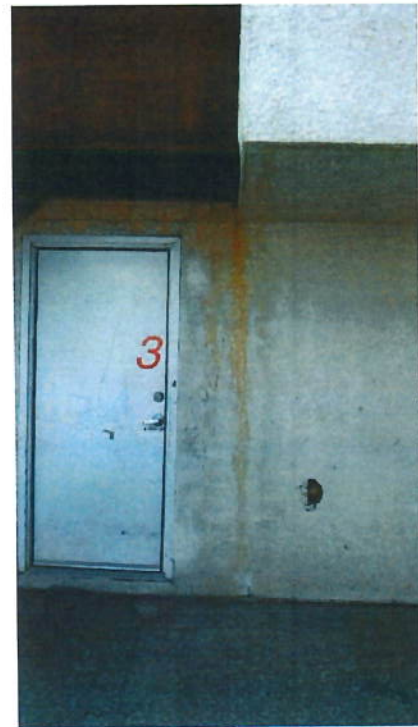
Fig. 12: Example of staining occurring on stucco due to stair corrosion.

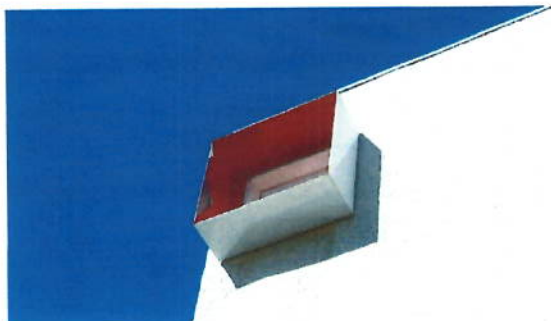
Fig. 13: Peeling window trims.

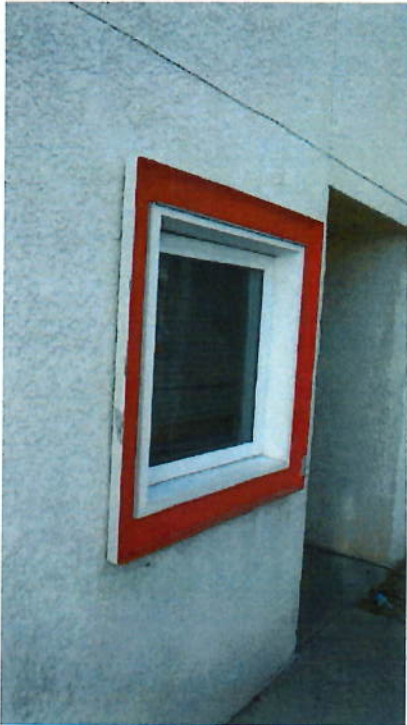
Fig. 14: Another example of peeling trim.

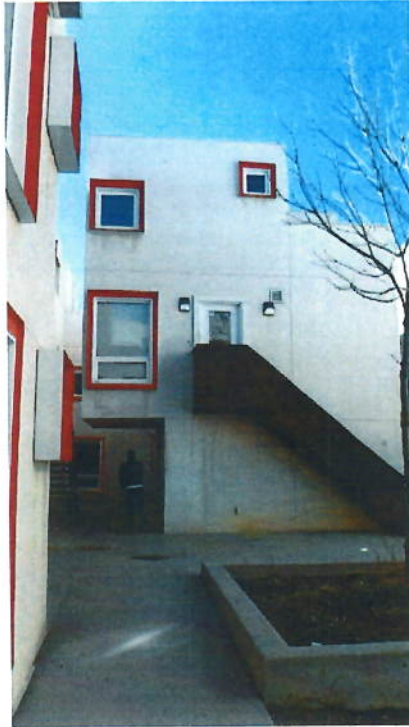
Fig. 17: Exterior example of cantilever dropping at outer edge.

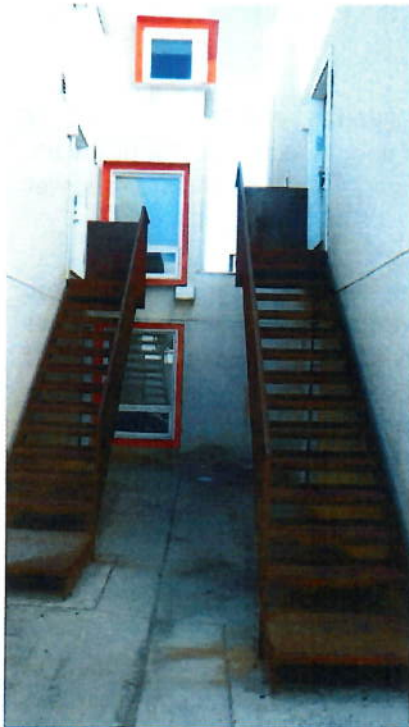
Fig. 18: A typical secluded entrance way where a security assessment may prove beneficial.
