**Archaeological Impact  
Assessment of the San Gold  
Resources Tailings  
Management Area Expansion  
(Quaternary Consultants  
Limited)**

**ARCHAEOLOGICAL IMPACT  
ASSESSMENT OF  
THE SAN GOLD RESOURCES  
TAILINGS MANAGEMENT AREA  
EXPANSION**

QUATERNARY  
CONSULTANTS  
LIMITED

June, 2009

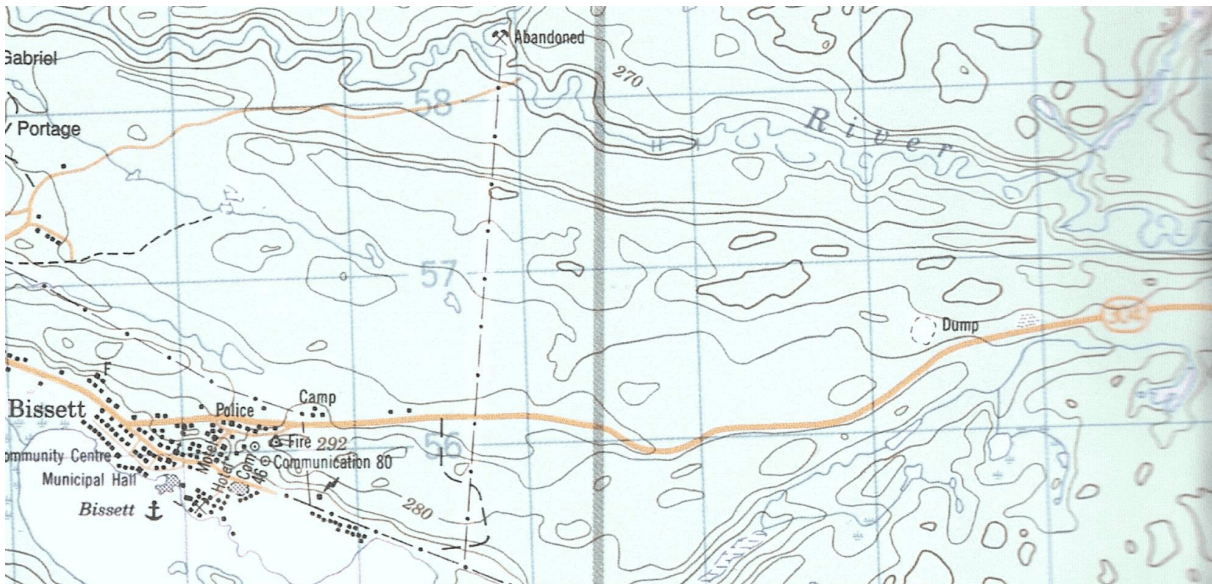
Figure 2: Enlarged Section of 1:50,000 Topographic Map

The San Gold Mine is located adjacent to the community of Bissett on the north shore of Rice Lake. The tailings pond areas (current and projected) lie primarily north of Highway PR 304. The location is depicted on Bissett 1:50,000 topographical map (52M/4). The map denotes no significant topographical features within the proposed tailings area (Figure 2).

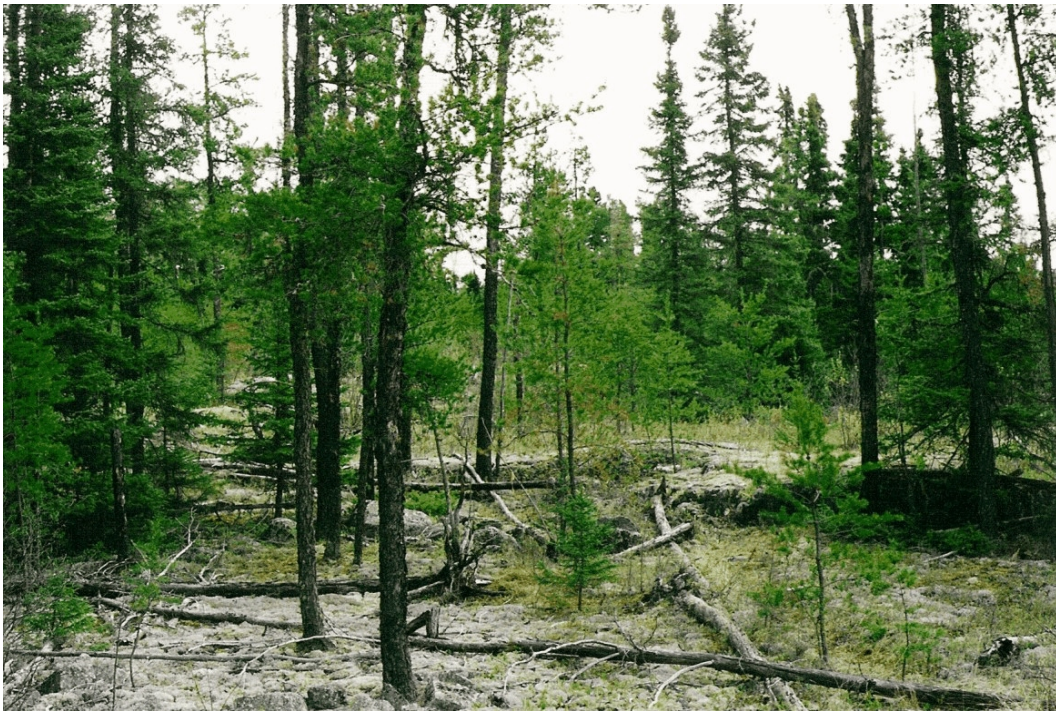
Plate 2: Bedrock Ridge

The entire area is a standard Boreal Forest biome with a sphagnum moss, black spruce, and tamarack swamp in the central low-lying area. The outcrop ridge is characterized by an open jack pine and spruce

forest. The ridge is bare outcrop in many areas with a mixed covering of lichen, sphagnum and low brush in sheltered areas. Visibility is very good. (Plate 2).

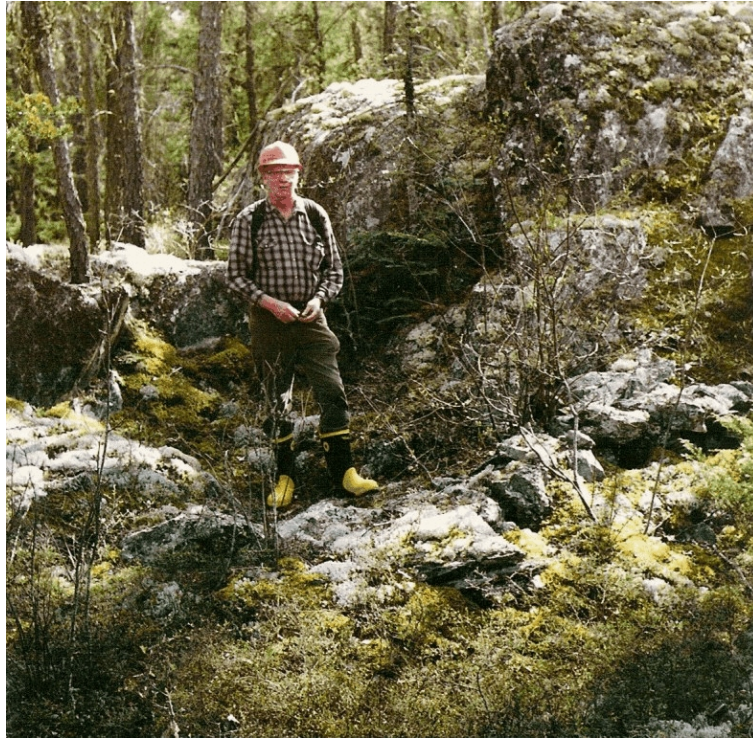
Plate 3: Rock Feature at Waypoint 307

Again, extensive mining activity was noted in many areas along this outcrop. Pits, blasted areas with evidence of drilling and chipping of quartz veins, as well as a veneer of broken glass and tin cans occurred throughout the area. Two rock features were identified as being potential evidence of early activity. These features are apparently arranged rock piles and were recorded as Waypoint 307 (Plate 3) and Waypoint 309. The feature at Waypoint 307 consists of a row of rocks piled on larger rocks and extends three metres north/south and 1.5 metres east/west. The feature at Waypoint 309 is even more minimal, consisting of one rock piled on a second. The primary reason for identifying these as potential heritage features is that they had a very thick lichen growth on the rock faces. No function could be attributed to either feature.

The Quaternary Consultants Ltd. crew walked several kilometres along two areas of rock outcrop north of the proposed tailings pond and several hundred metres along the outcrops at SG1 and SG2. During the course of the investigations widespread mining activity was identified on all outcrops located in the development area. Two features that may be related to earlier activity also were located. These features are of minor importance and may or may not be related to early Aboriginal activity. Their function could not be identified.

Based upon the total lack of observed cultural resources, **Quaternary Consultants Ltd. can recommend that no further archaeological work is required for this project.**
