Winter Field Data Report for Water
Quality Study for Hylife Foods
Facility Expansion

Final Report

Hylife Foods LP

Stantec Consulting Ltd.

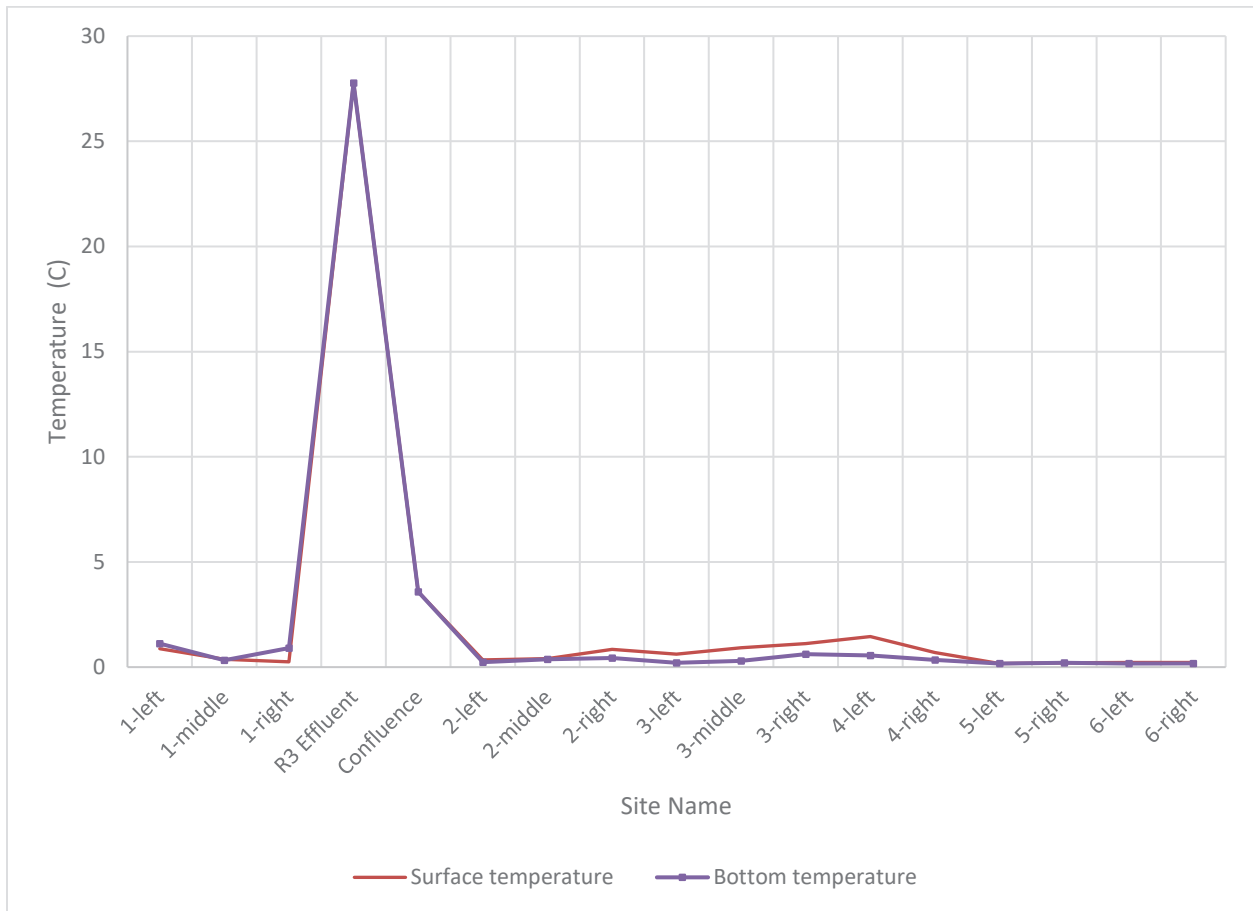
Figure 4-1 Temperature Readings from Surface and Bottom (or mid-stream where not discernible) at Sites 1-6, the R3 Innovations Effluent, and the Confluence of the Wetland Area and the Whitemud River

Temperature readings at all sites showed similar readings from surface and bottom, with temperature ranging at Sites 1-6 from 0.17°C at Site 5 to 1.45°C at Site 4 (Figure 4-1). Temperature of the R3 Innovations effluent measured directly under the outfall pipe was 27.78°C. As the effluent passed through the wetland area, temperature was reduced as shown in the temperature reading at the wetland outlet of 3.58°C, contributing to the visible open water in the Whitemud River (Appendix B; Photo ID 5 and 8).

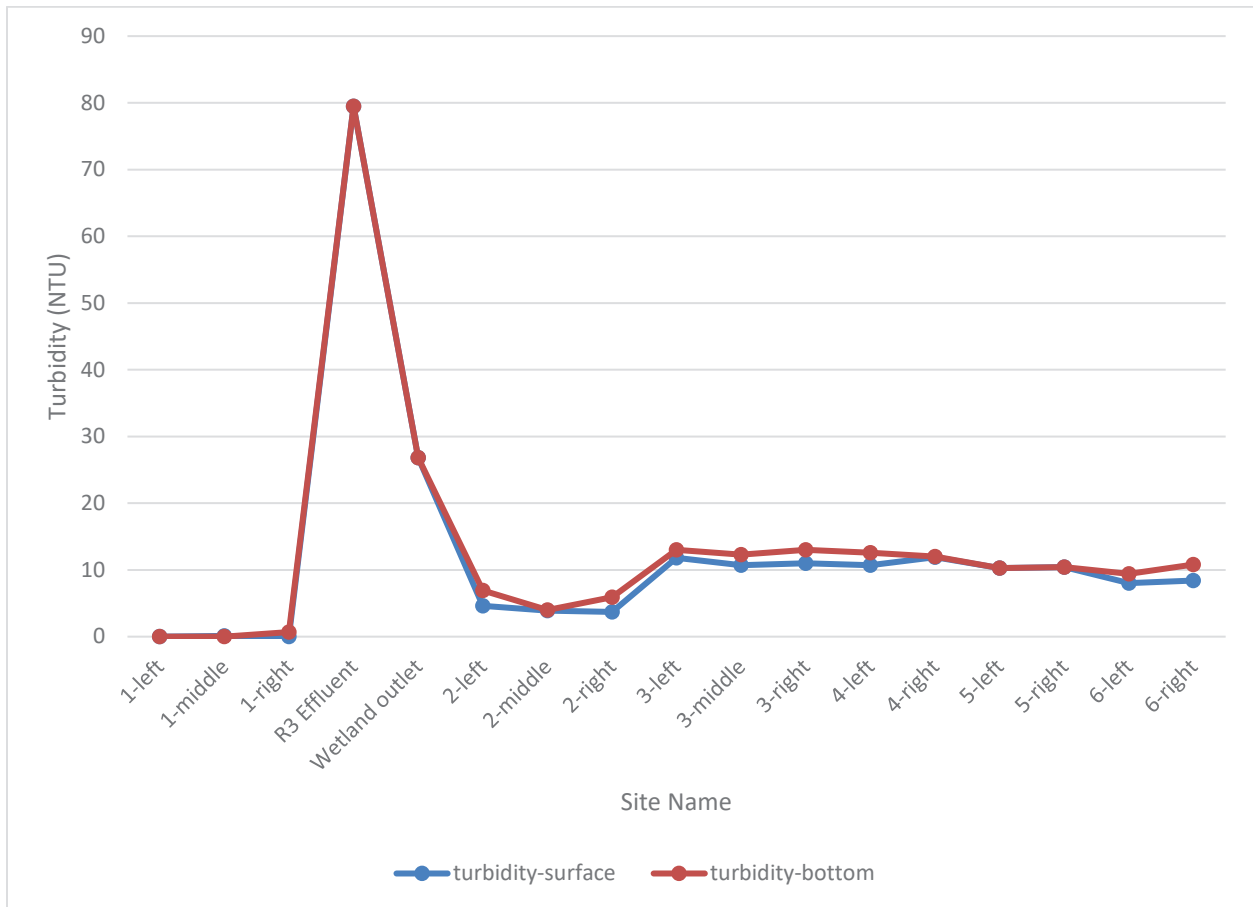
Figure 4-2 Turbidity Readings at Surface and Bottom (or mid-stream where not discernible) at Sites 1-6, the R3 Innovations Effluent, and the Confluence of the Wetland Area and the Whitemud River

Turbidity measurements varied across Whitemud River Sites 1-6 with a minimum of 0 NTU (Site 1) to a maximum of 13 NTU (Site 3). The R3 Innovations effluent had a turbidity level of 79.5 NTU that decreased to 26.8 NTU at the wetland outlet (Figure 4-2). Turbulence at the outfall was observed as shown in Appendix B; Photo ID 25. For Whitemud River Sites 1-6, turbidity showed lower levels recorded at Site 1 (0 NTU) and increased levels downstream at Sites 4, 5 and 6 with turbidity readings of 8.0-12.6 NTU.

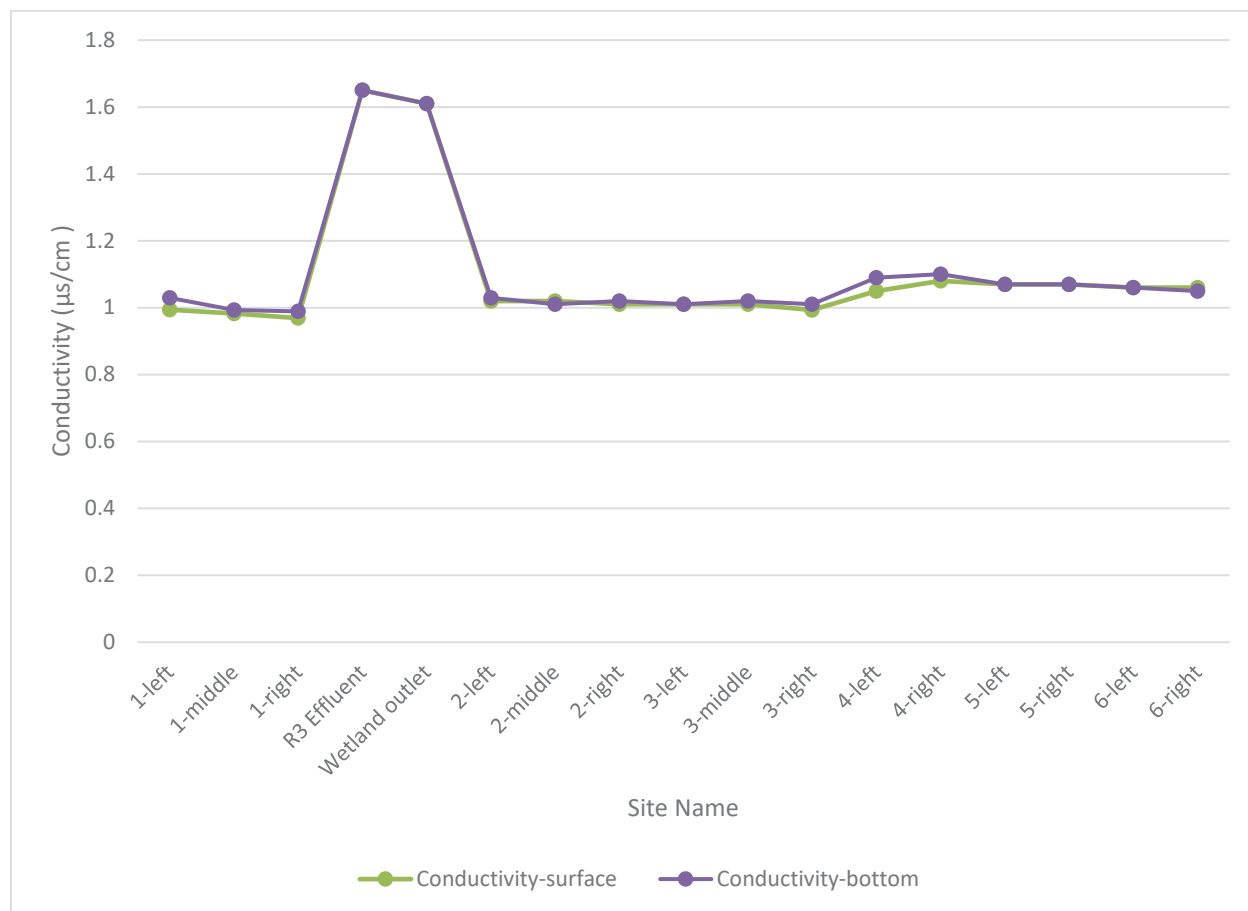
Figure 4-3 Conductivity Readings at Surface and Bottom (or mid-stream where not discernible) at Sites 1-6, the R3 Innovations Effluent, and the Confluence of the Wetland Area and the Whitemud River

Conductivity was elevated at the R3 Innovations outfall, with a reading of 1.65 $\mu\text{s}/\text{cm}$, which fell to 1.61 $\mu\text{s}/\text{cm}$ at the wetland outlet. Lower conductivity levels were observed at Site 1 (0.989 $\mu\text{s}/\text{cm}$) and increased downstream at Sites 4, 5 and 6 with conductivity readings between 1.05 $\mu\text{s}/\text{cm}$ and 1.1 $\mu\text{s}/\text{cm}$ (Figure 4-3).

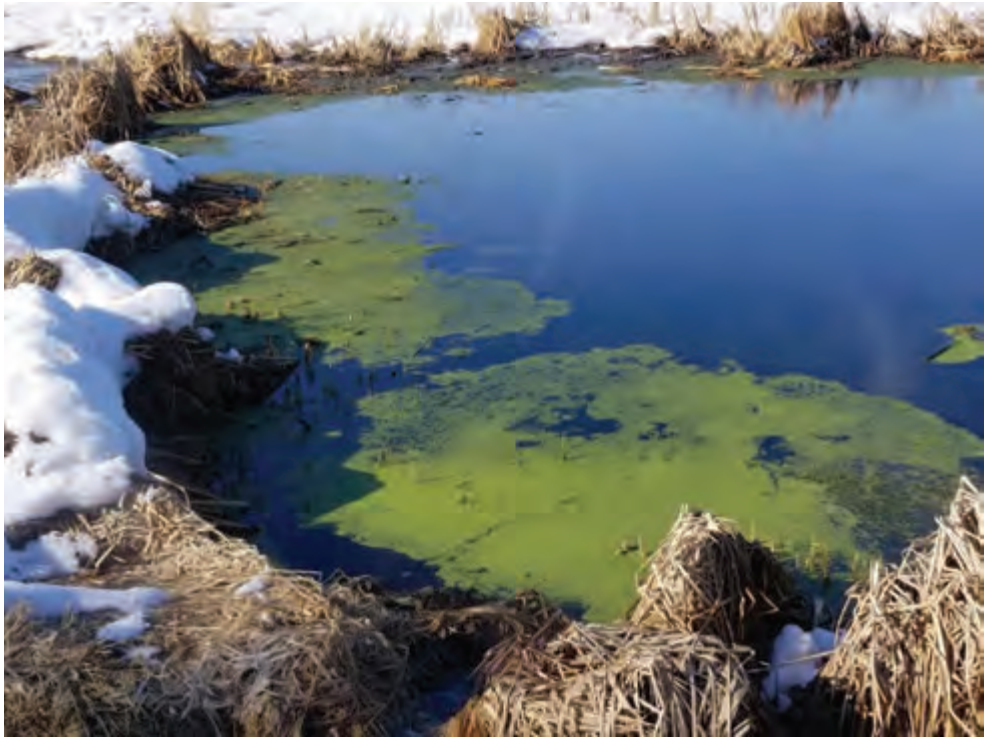
Client:	Hylife	Project:	111440368
Site Name:	Water Quality Study	Site Location:	Neepawa, MB
Photograph ID: 1

Photo Location: Wetland area downstream of R3 Innovations outfall			
Direction: north			
Survey Date: 2/24/2020			
Comments: Abundant open water, duckweed and small bodied fish present			
Photograph ID: 2

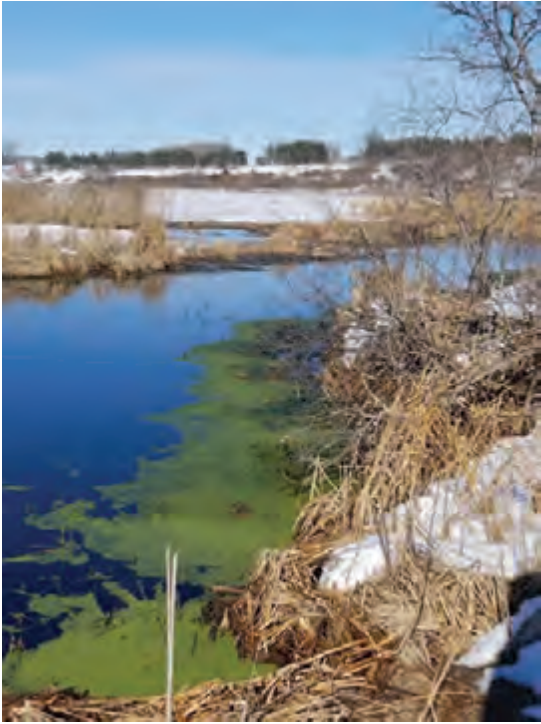
Client:	Hylife	Project:	111440368
Site Name:	Water Quality Study	Site Location:	Neepawa, MB
Photograph ID: 3

Photo Location: Wetland area downstream of R3 Innovations outfall			
Direction: northeast			
Survey Date: 2/24/2020			
Comments:

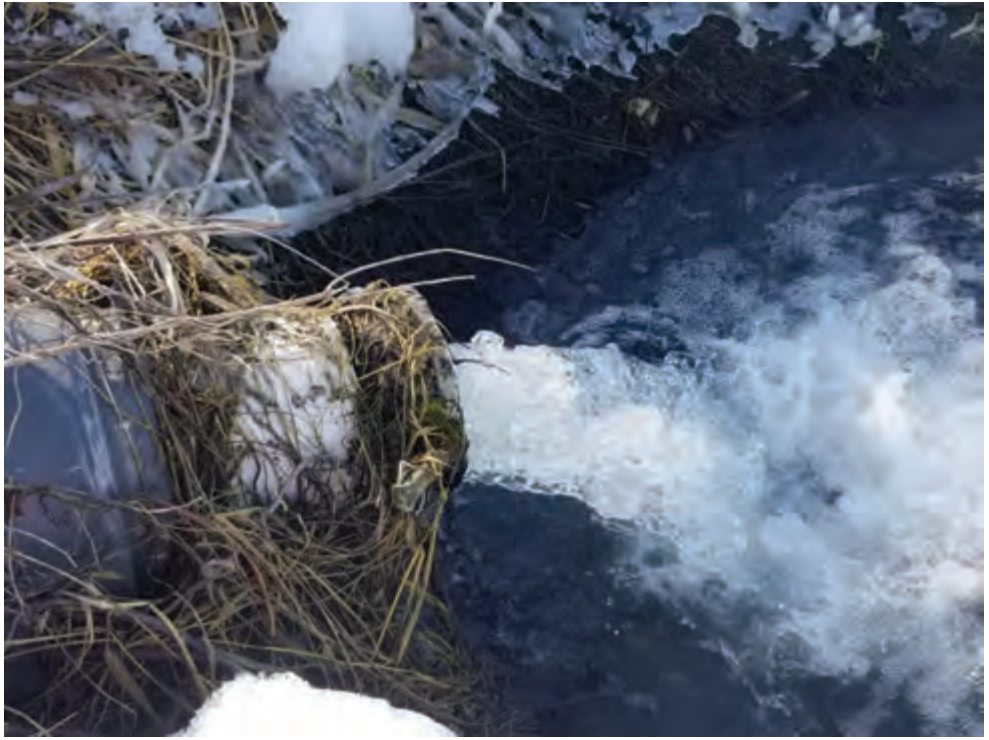
Photo Location: R3 Innovations effluent outfall structure			
Direction: n/a			
Survey Date: 2/24/2020			
Comments: Continous discharge with temperature of approximately 27C			
Photograph ID: 4

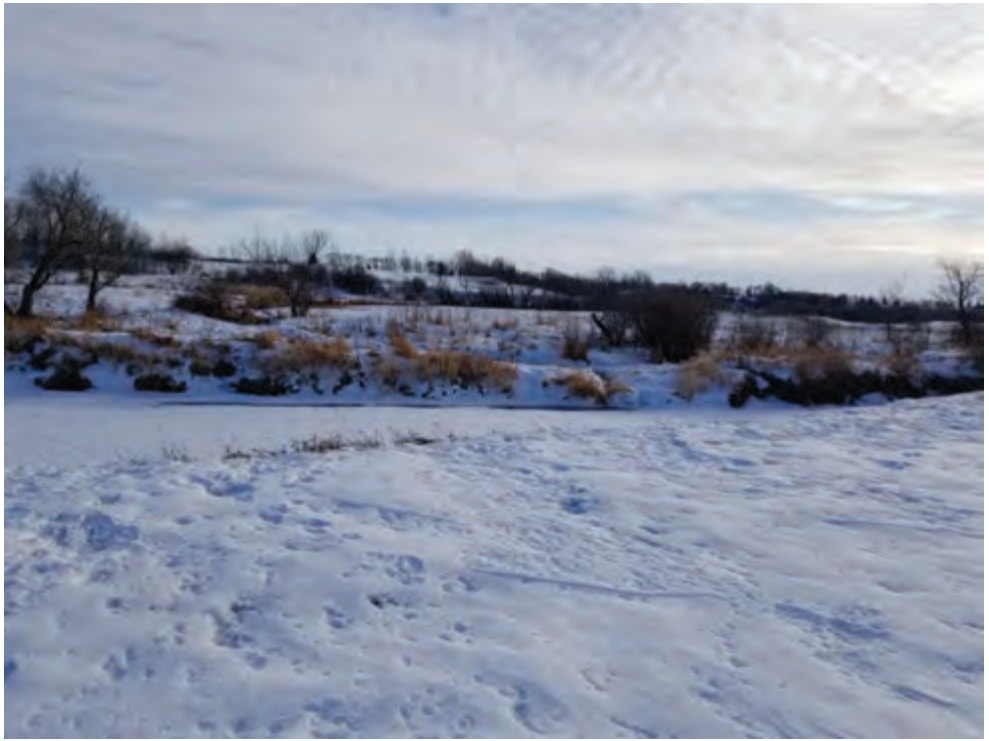
Photo Location: Secondary confluence observed on Whitemud River			
Direction: south			
Survey Date: 2/24/2020			
Comments: Identified by area of open water coming off wetland area

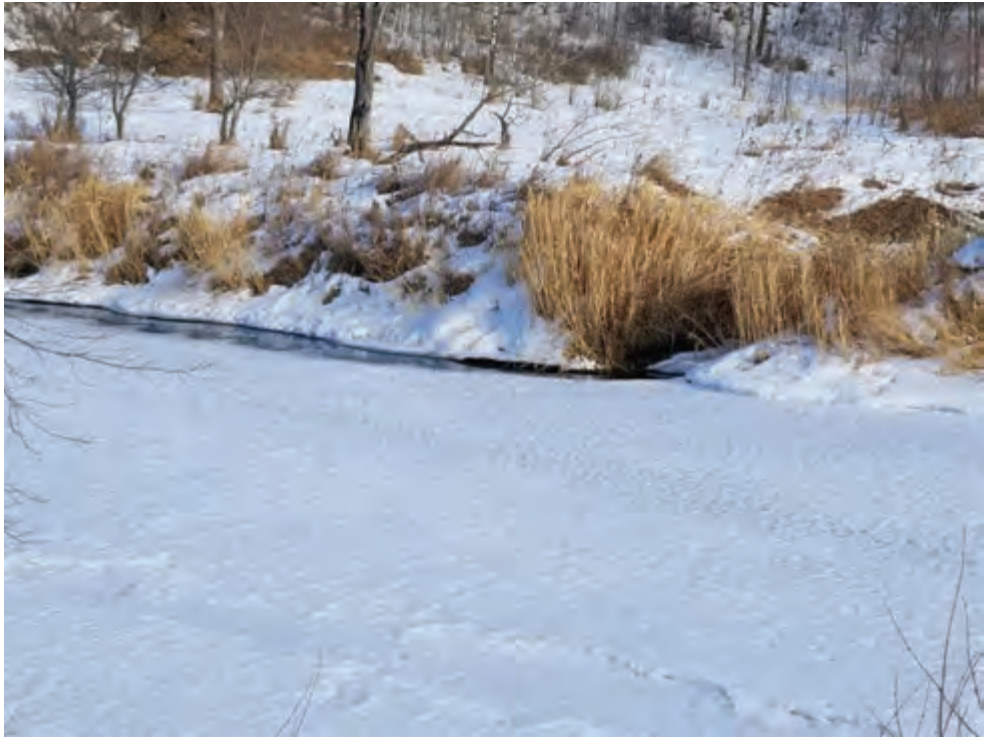
Client:	Hylife	Project:	111440368
Site Name:	Water Quality Study	Site Location:	Neepawa, MB
Photograph ID: 5

The rationale and description of the six sampling sites along the Whitemud River is presented in Section 2.2 of the open water field data report (Stantec 2019). The R3 Innovations outfall was also selected for water quality and flow monitoring during the winter 2020 field program since it is the direct wastewater input of interest for the Hylife expansion. The R3 Innovations effluent discharges via outfall to a low-lying wetland area covering approximately 1.13 ha of land north of the effluent outfall. The wetland area drains to the Whitemud River via an apparent outlet 300 m downstream (northeast) of the R3 Innovations outfall structure at UTM coordinates 14 U 469135 m E 5565220 m N. A second apparent outlet from the wetland to the Whitemud River was also noted during the winter field program. It is located at UTM coordinates 14U 468998 m E 5565186 m N (150 m upstream of the primary/larger outlet). To better understand the effect of the effluent flowing through the wetland area, water quality monitoring and sampling was conducted at the confluence of the primary wetland outlet and the Whitemud River (Appendix B; Photo ID 5 and 6).

Photo Location: Primary confluence observed on Whitemud River			
Direction: southeast			
Survey Date: 2/24/2020			
Comments: Sampling location "Confluence"			
Photograph ID: 6

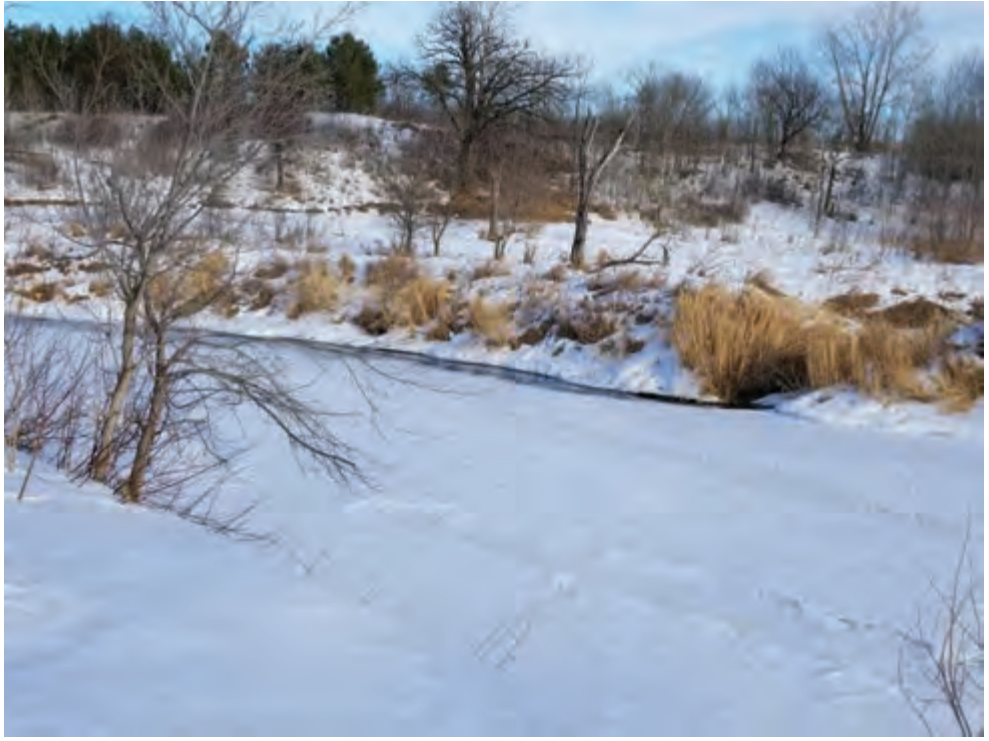
Client:	Hylife	Project:	111440368
Site Name:	Water Quality Study	Site Location:	Neepawa, MB
Photograph ID: 7

Sites were characterized through general field observations such as snow conditions, weather conditions, and notable site features. Notable observations included the open water in the wetland area with visible steam at the effluent outfall, vegetation growth of duckweed (*Lemna minor*), and visible small bodied fish (Appendix B; Photo ID 1 and 3). Observations indicated that the entire wetland area was open water. An open water plume (approximately 1-2 m in width), was also visible extending from the wetland outlet into the Whitemud River and continuing approximately 110 m downstream, covering an area of approximately 165 m² in the Whitemud River (Appendix B; Photo ID 5 and 8). In the open water plume, North American

Photo Location: Open water plume downstream of confluence on Whitemud River			
Direction: southeast			
Survey Date: 2/24/2020			
Comments:

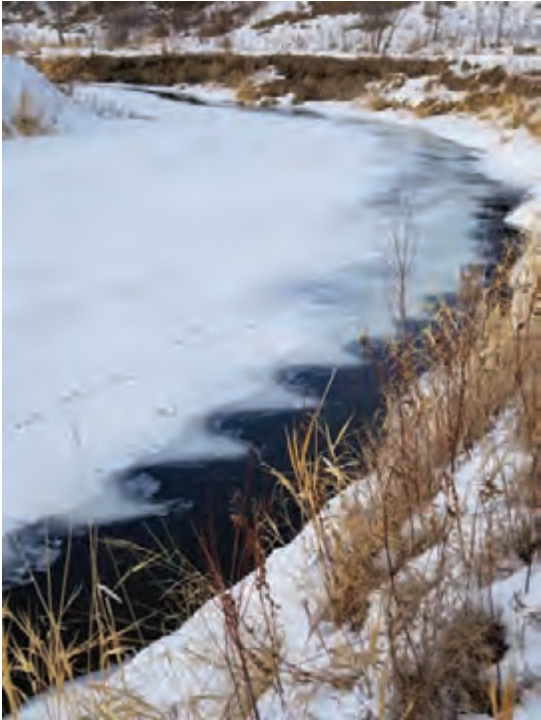
Photo Location: Open water plume, facing downstream			
Direction: northeast			
Survey Date: 2/24/2020			
Comments: Plume approximately 1-2 m wide, 75 m length

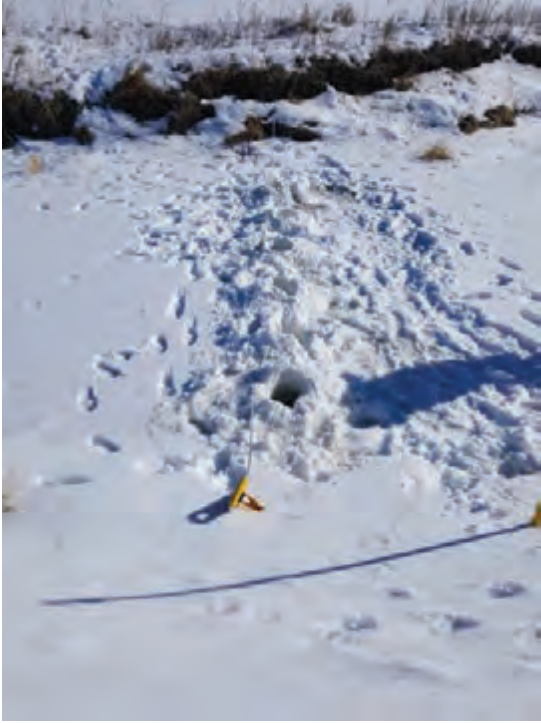
Client:	Hylife	Project:	111440368
Site Name:	Water Quality Study	Site Location:	Neepawa, MB
Photograph ID: 9

River Otters (*Lontra canadensis*) were also observed. At Site 6, flooding of the roadway from the fall was evident, as the road was covered in ice. Open water was also observed near the culverts at Site 6 (Appendix B; Photo ID 24). Snow thickness varied across sites ranging from approximately 3-5 cm at Site 6, to approximately 20 cm at Sites 1 and 3 (Appendix B; Photo ID 9 and 22).

Photo Location: Site 1, facing right bank			
Direction: east			
Survey Date: 2/24/2020			
Comments: holes drilled approximately 1 m apart			
Photograph ID: 10

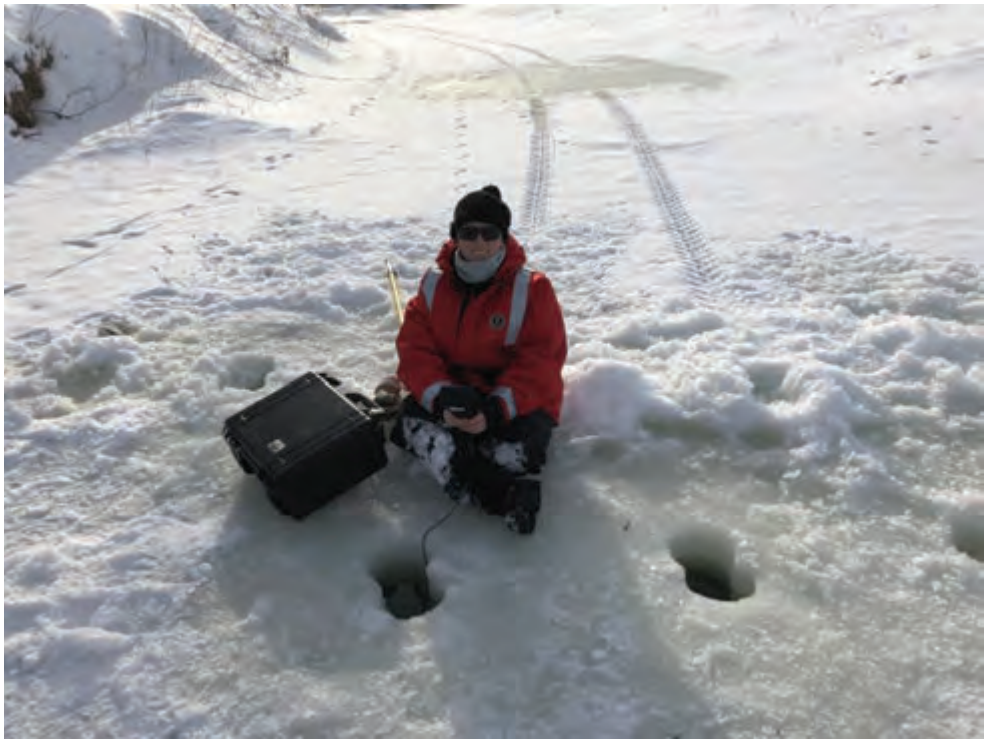
Client:	Hylife	Project:	111440368
Site Name:	Water Quality Study	Site Location:	Neepawa, MB
Photograph ID: 11

Photo Location: Site 2			
Direction: west			
Survey Date: 2/26/2020			
Comments: water monitoring

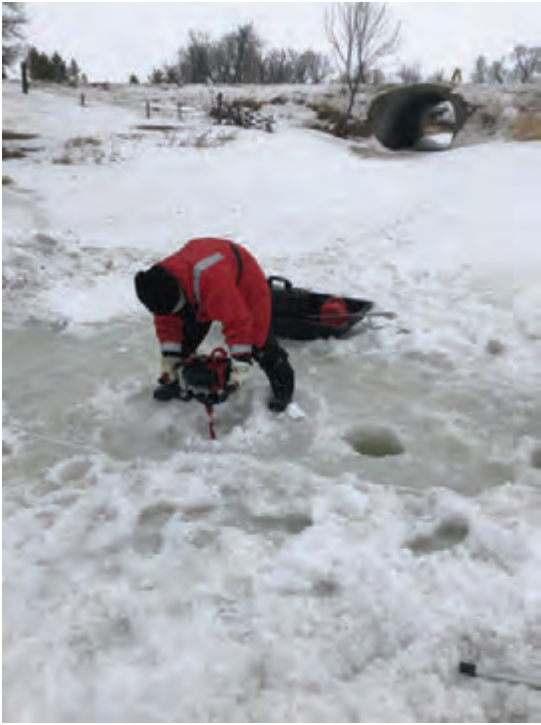
Client:	Hylife	Project:	111440368	
Site Name:	Water Quality Study	Site Location:	Neepawa, MB	
Photograph ID: 13

Photo Location:				Site 3
Direction:				east
Survey Date:				2/25/2020
Comments:				>1 m of ice cover and showing distance to road culvert
Photograph ID: 14

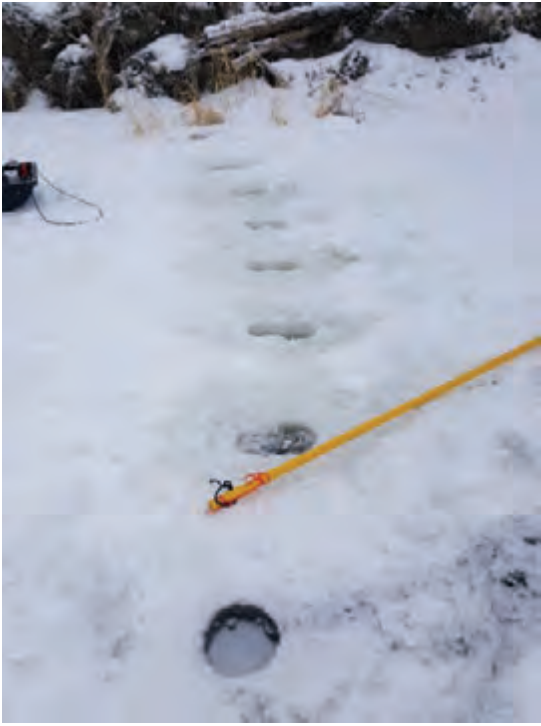
Photo Location:				Site 4, right bank
Direction:				south
Survey Date:				2/27/2020
Comments:				<5 cm snow cover

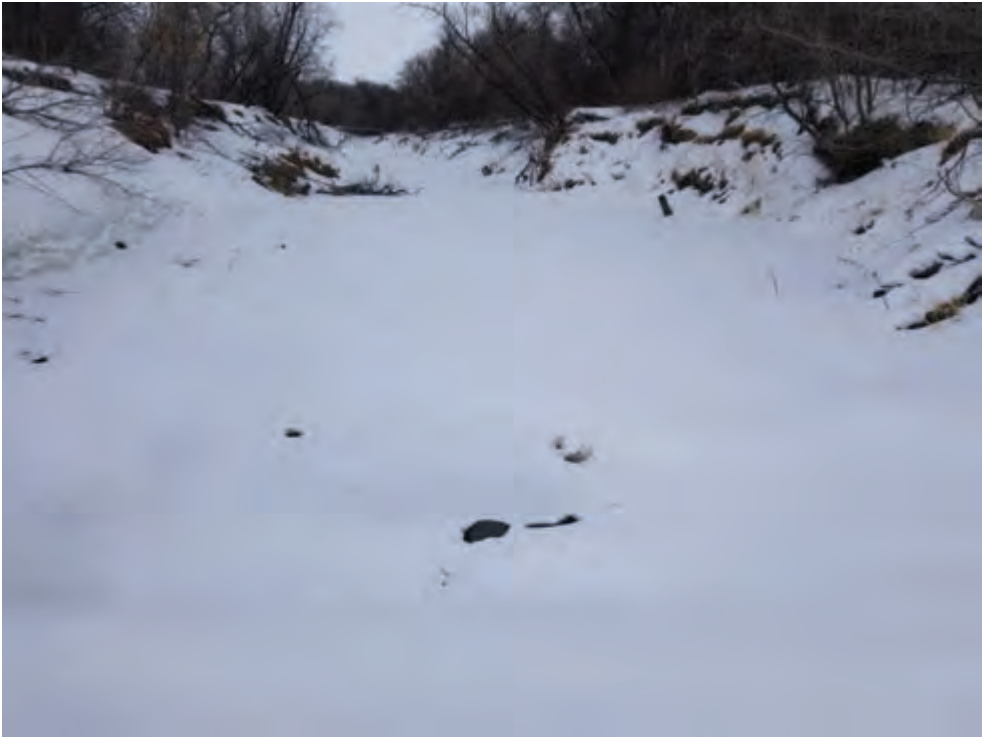
Photo Location:			
Site 6, facing upstream from bridge			
Direction:			
west			
Survey Date:	2/27/2020		
Comments:	showing open water areas and ice jamming

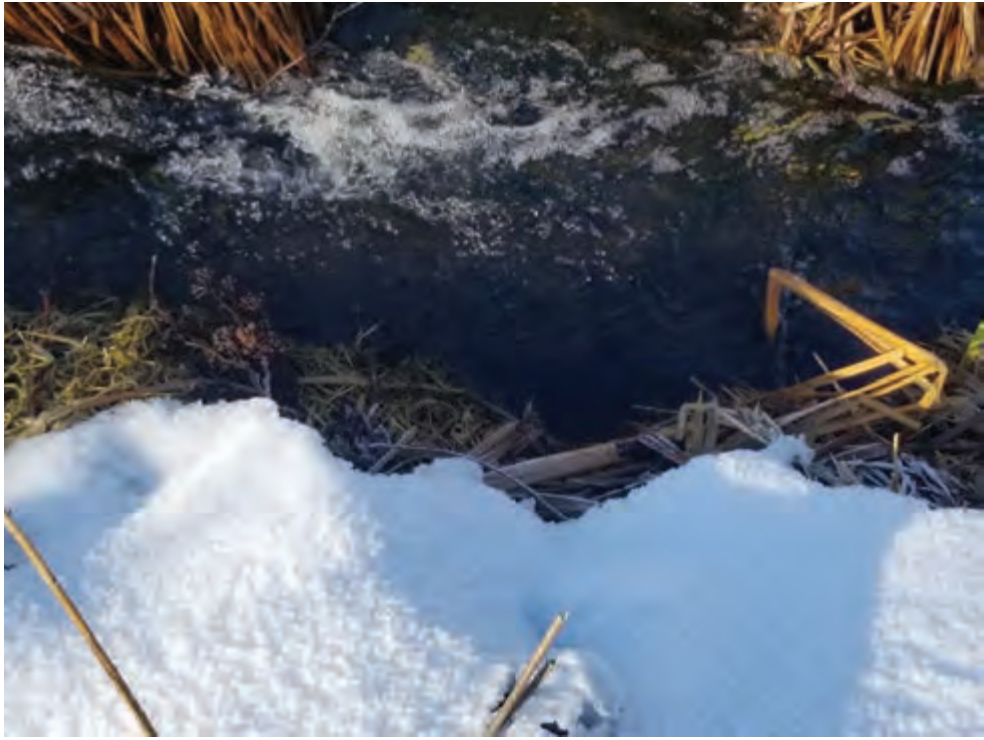
Photograph ID: 25

Photo Location: Wetland area, downstream of outfall	
Direction: n/a	
Survey Date: 2/24/2020	
Comments: showing turbulence
