# Lake Winnipeg East System Improvement Transmission Project Environmental Effects Monitoring Report

Prepared by:  
Manitoba Hydro  
Winnipeg, Manitoba  
November 2018

Version – Final 2.0

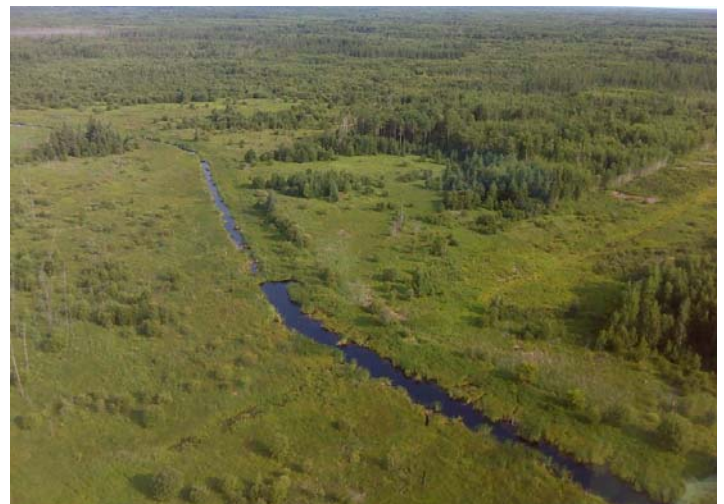
**Photo 5:** A small creek south of the Sandy River showing the preservation of the riparian zone and regrowth of vegetation along the ROW

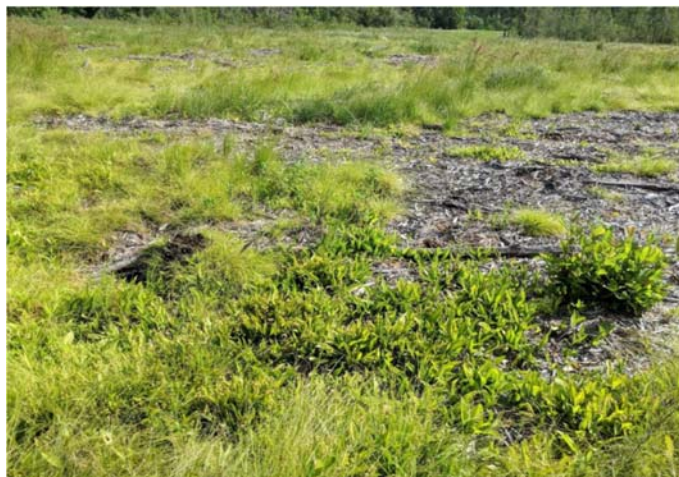
**Photo 6: Herbaceous vegetation regrowth on the ROW**

Surveys conducted from July 24-27, 2018 at seven plots identified that most species of conservation concern (SCC) were in good condition with some potentially benefiting from the right-of-way clearing activities as a result of additional sunlight and reduced competition afforded to herbaceous plants.

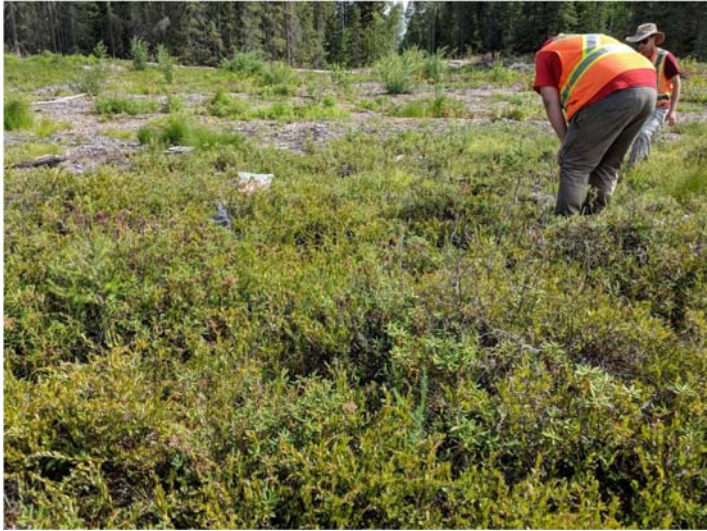
**Photo 7: Monitoring plot with healthy, fruit-bearing plants within the ROW**

Surveys conducted July 24-27, 2018 at 17 plots identified that most species of importance to Indigenous peoples appeared to be thriving in the Project ROW.

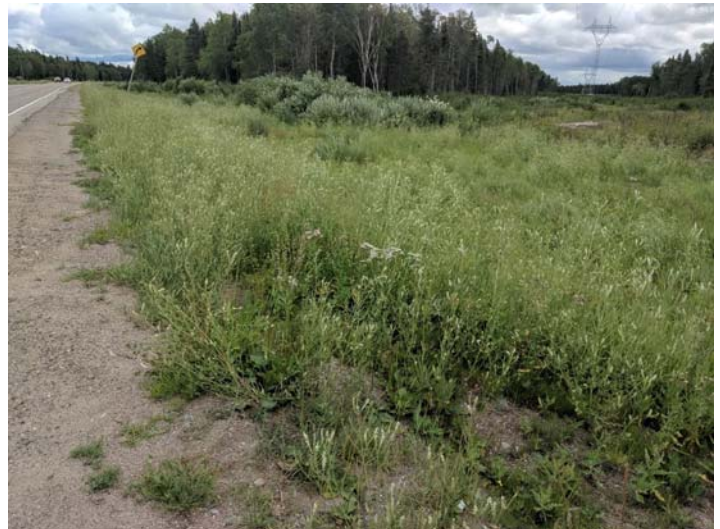
**Photo 8: Highway crossing with encroaching white sweet clover**

Surveys were conducted in July 2018 at key locations along the ROW. White sweet clover (*Melilotus albus*) and Canada thistle (*Cirsium arvense*) continue to be the two most prevalent non-native and invasive species within the right of way.

As predicted in the EA, Project construction had minimal effect on the spread of invasive species. Non-native or invasive plants were observed along some portions of the transmission line, typically close to PTH 304, but these species were very likely present prior to the clearing of vegetation and have since benefitted from the reduction in tree and shrub cover. These species continue to be found only within upland areas with wetland communities largely free of these species.

Manitoba Hydro and its contractors will continue to apply a clean equipment protocol to limit the spread of these species.

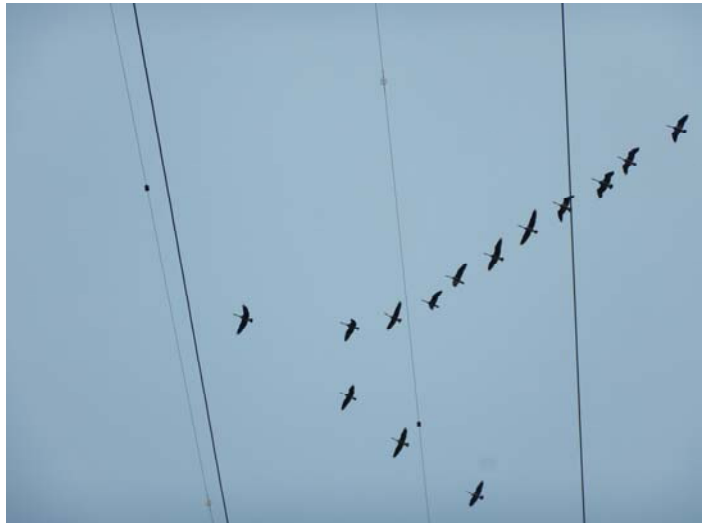
Mitigation efforts, including Project routing and installation of bird diverters appear to be effective.

**Photo 10:** Canada geese migrating over the transmission line. Bird diverter devices were installed in areas of high bird activity.

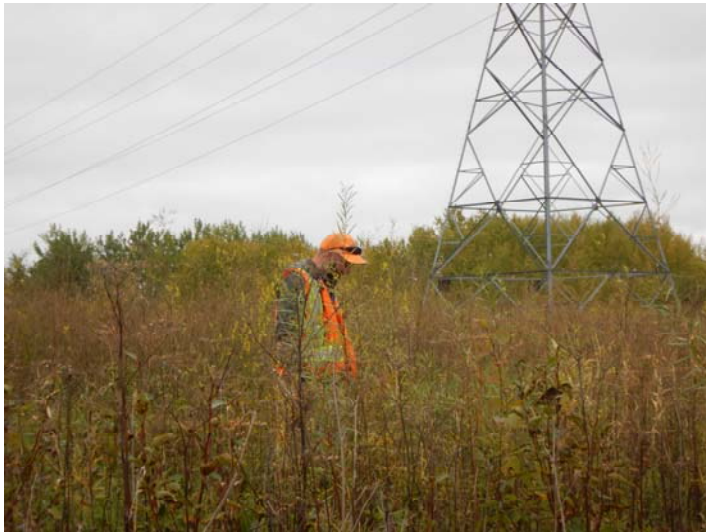
The presence of transmission lines in proximity to areas of high bird activity may lead to bird – wire collisions. Manitoba Hydro installed bird diverters along transmission line sections that transect areas of high bird activity. Pre-construction surveys identified sensitive sites for birds, which were used to select locations for bird diverters. Bird-wire collision monitoring was conducted in the spring and autumn of 2018, after the project was completed.

**Photo 9:** Biologist conducting a bird-wire collision survey along the right of way
