**Environmental Review and Project Assessment Report (ERPAR):**

**Proposed PTH 1A (First Street) Bridges over the  
Assiniboine River – Existing Site #2582-00**

**Prepared by: Manitoba Infrastructure and Transportation  
Water Management and Structures**

**June 2015**

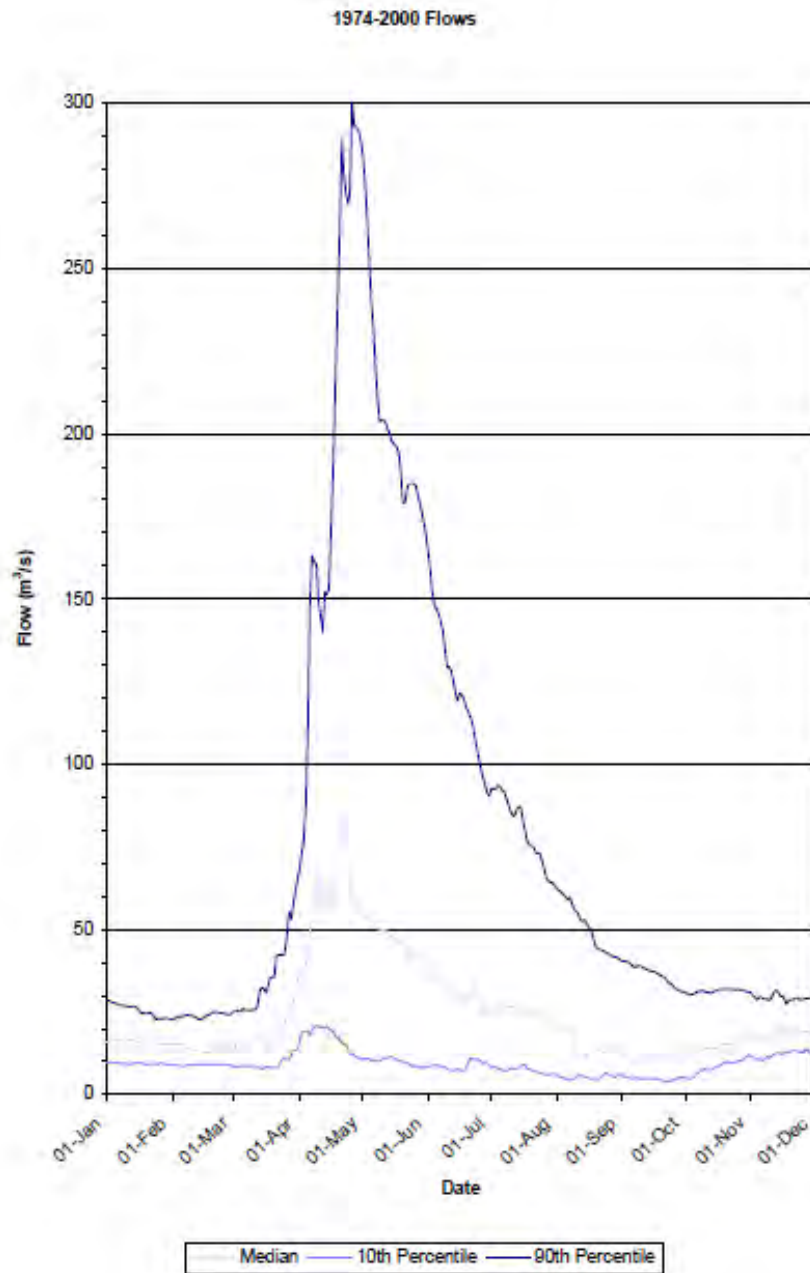
Figure 5 Daily discharge of the Assiniboine River near Brandon. Data from Environment Canada, Water Survey of Canada (WSC) gauge 05MH013, from 1974 – 2000. (North/South Consultants Inc., 2006-12 – “Assiniboine River Bridge Construction, PTH 10 – 18<sup>th</sup> Street Brandon, Fish Habitat Assessment”).

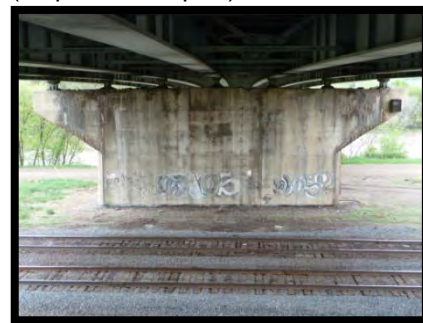
Photo 6 – Looking (north) at the southern pier near CP rail, May 29, 2013 (Inspection Report).

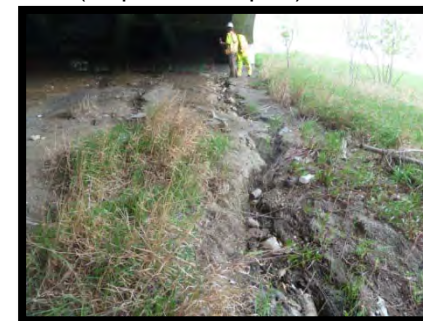
Photo 9 – South embankment with severe erosion trough, May 29, 2013 (Inspection Report).

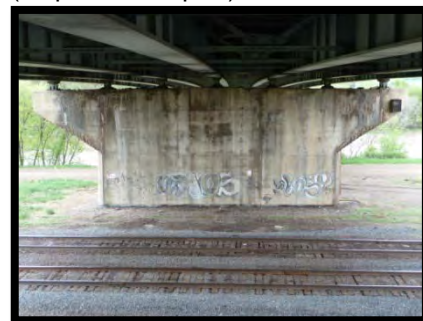
Photo 6 – Looking (north) at the southern pier near CP rail, May 29, 2013 (Inspection Report).
